# Manhole Inspection Summary

Manhole # S55M\_\_033MH

Insp Date: **10/27/08 12:34 PM**

**Location** Address: **s conkling st**

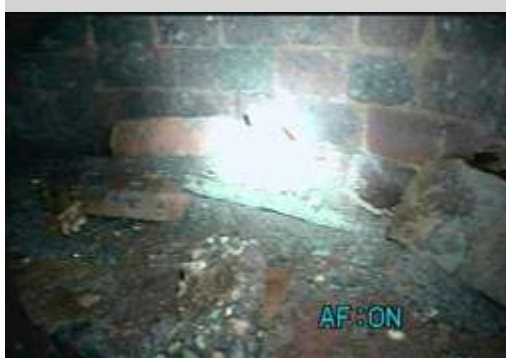
Defect 3

Condition: ☐ Sound ☐ Cracked ☐ Root Intrusion ☐ Deteriorated ☐ Leaks ☒ **Debris**

bench debris

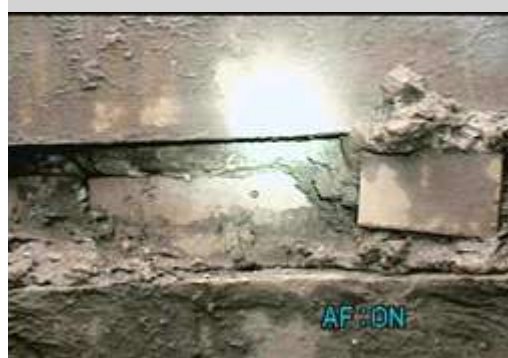
Defect 2

Condition: ☐ Sound ☐ Cracked ☐ Root Intrusion ☒ **Loose Brick** ☒ **Deteriorated**

Infiltration: ☐ None ☒ **Joint** ☐ Cracks ☐ Mortar ☐ Roots ☐ Wall

Loose Bricks, Deterioration and Infiltration in Chimney

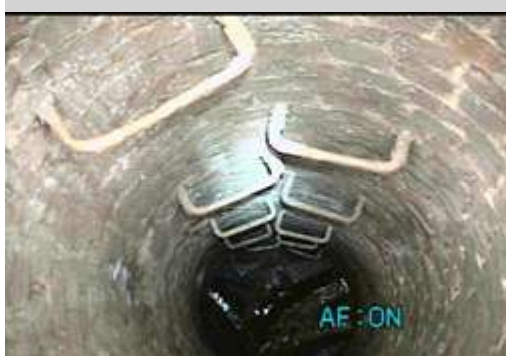
Defect 1

Count: **10** Missing: **0** ☒ **Corroded**

cor. steps

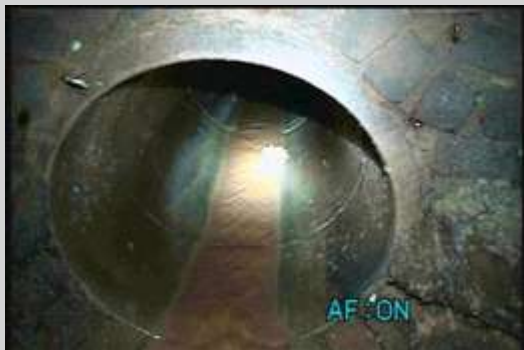
12 O'Clock Outflow

18 in. Circular Gravity Sewer  
Pipe Out @ 12 OClock

Invert Depth: 17.54 (ft.) Flow Characteristics: Fast

Infiltration: None Pipe Seal Cond: Unknown

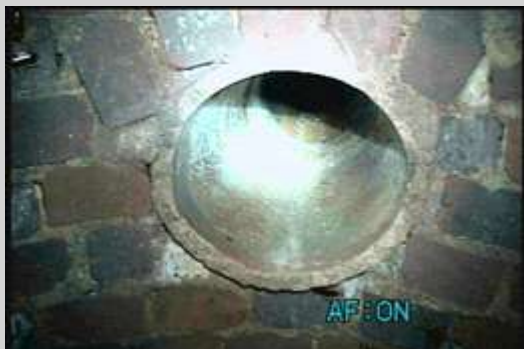
3 O'Clock Inflow

8 in. Circular Gravity Sewer  
Pipe In @ 3 OClock

Invert Depth: 12.00 (ft.) Flow Characteristics: None

Infiltration: None Pipe Seal Cond: Unknown

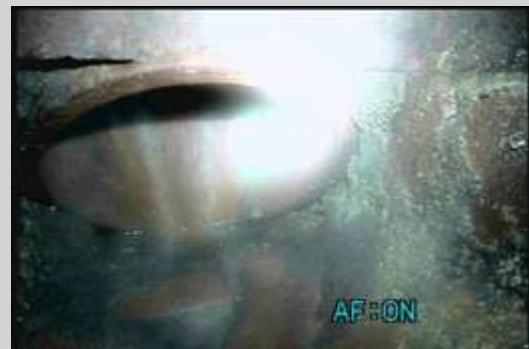
Drop In @ 3 OClock

couldnt get better pic, pipe on an angle

Drop: Outside Direct

Drop Condition: Open

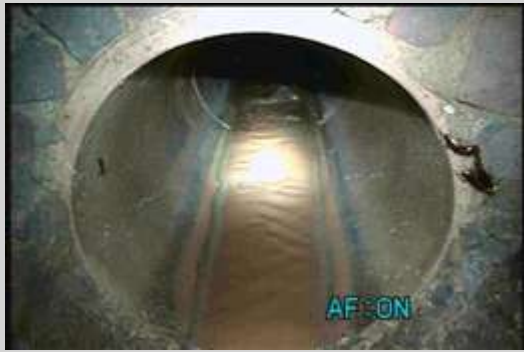
7 O'Clock Inflow

18 in. Circular Gravity Sewer

Pipe In @ 7 O'Clock

Invert Depth: **17.20** (ft.) Flow Characteristics: **Fast**

Infiltration: **None** Pipe Seal Cond: **Unknown**

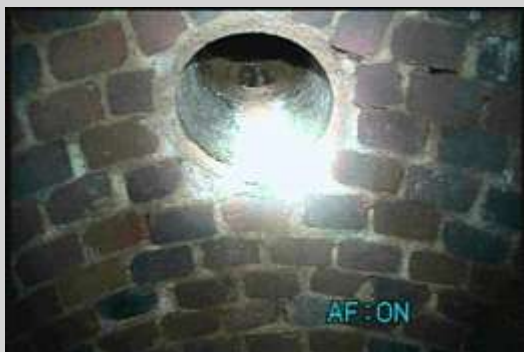
9 O'Clock Inflow

8 in. Circular Gravity Sewer

Pipe In @ 9 O'Clock

Invert Depth: **11.70** (ft.) Flow Characteristics: **Fast**

Infiltration: **None** Pipe Seal Cond: **Unknown**

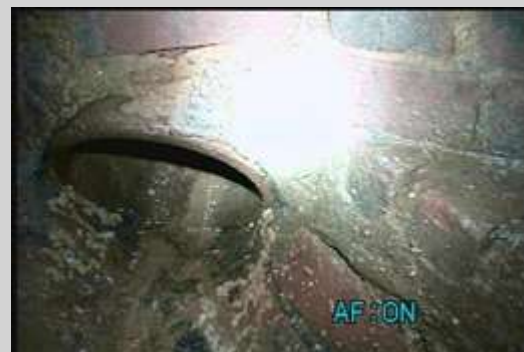
Drop In @ 9 O'Clock

Drop: **Outside Direct**

Drop Condition: **Open**
